'Mystery Bomber'

A Project for OMRS Convention 2020

by Chris Bacon

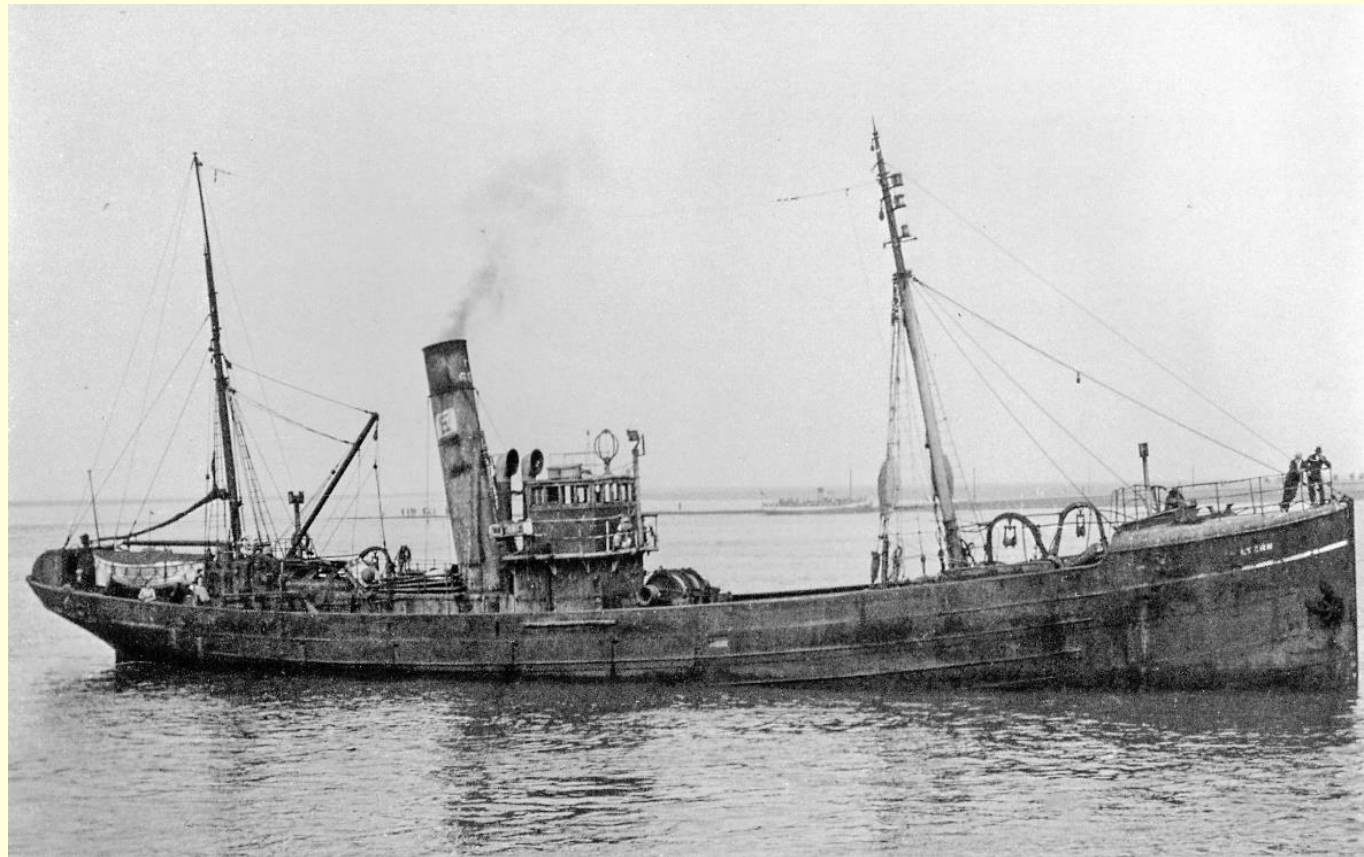
Fig. 13 HMT Chiltern.

The 12 pdr HA gun (see *Fig 14* right) was located forward of the main mast in the position of the two lifting 'A' frames

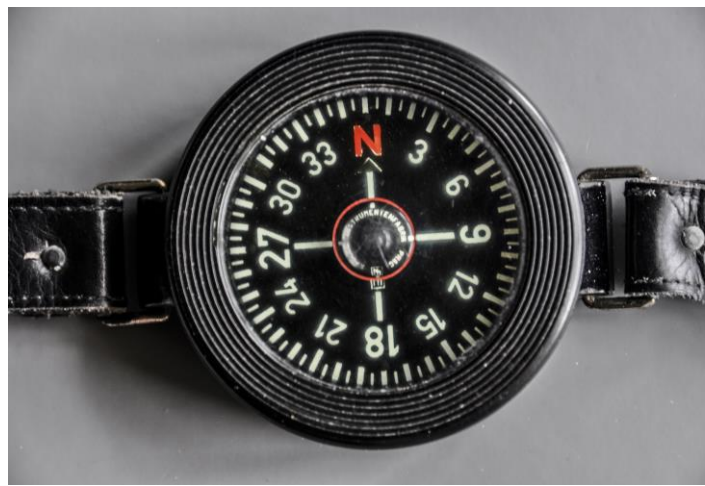
Fig. 22 Obverse of Wrist Compass

Physical Description of the compass. Diameter: 61 mm: Depth 23 mm. Moulded black Bakelite body with a clear window through which the compass rose is visible.

The blackened leather wrist strap is fitted with alloy buckles and includes the extending strap that permits the compass to be worn over a bulky flying suit.

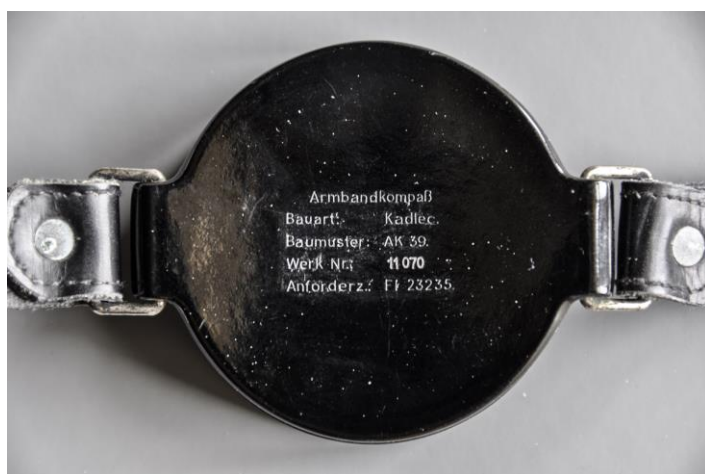
Fig. 23 Reverse of Wrist Compass 39

*Bauert: Kadlec
Baumuster: AK39
Werk Nr : 11070;
Anfordez.: FI 23235'*

This compass illustrated lacks the 'lubber line' seen on the few examples found on the internet, each of which bears a Werk Nr far higher (in the range 61,000-70,000), so with a Werk Nr of 11070 the illustrated compass is an early production/early war period model that is in almost mint condition: These features are consistent with the date of its capture.

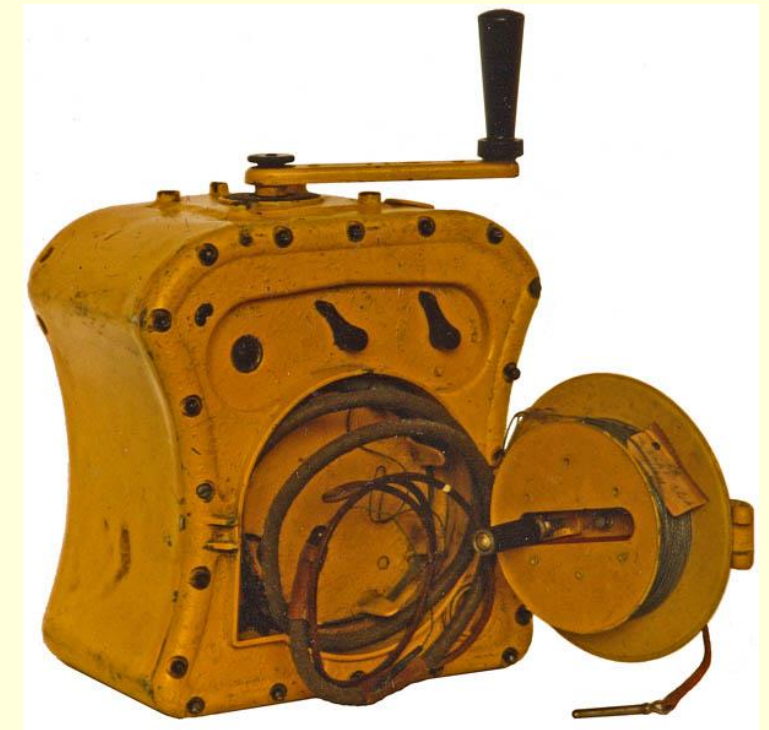
Fig. 25 Emergency Transmitter SCR 578 'Gibson Girl'
(source: *Wireless for the Warrior*)

The U.S. military also needs an emergency transmitter and the T-1333 design is further modified by the U.S. and goes into service as the SCR 578 transmitter.

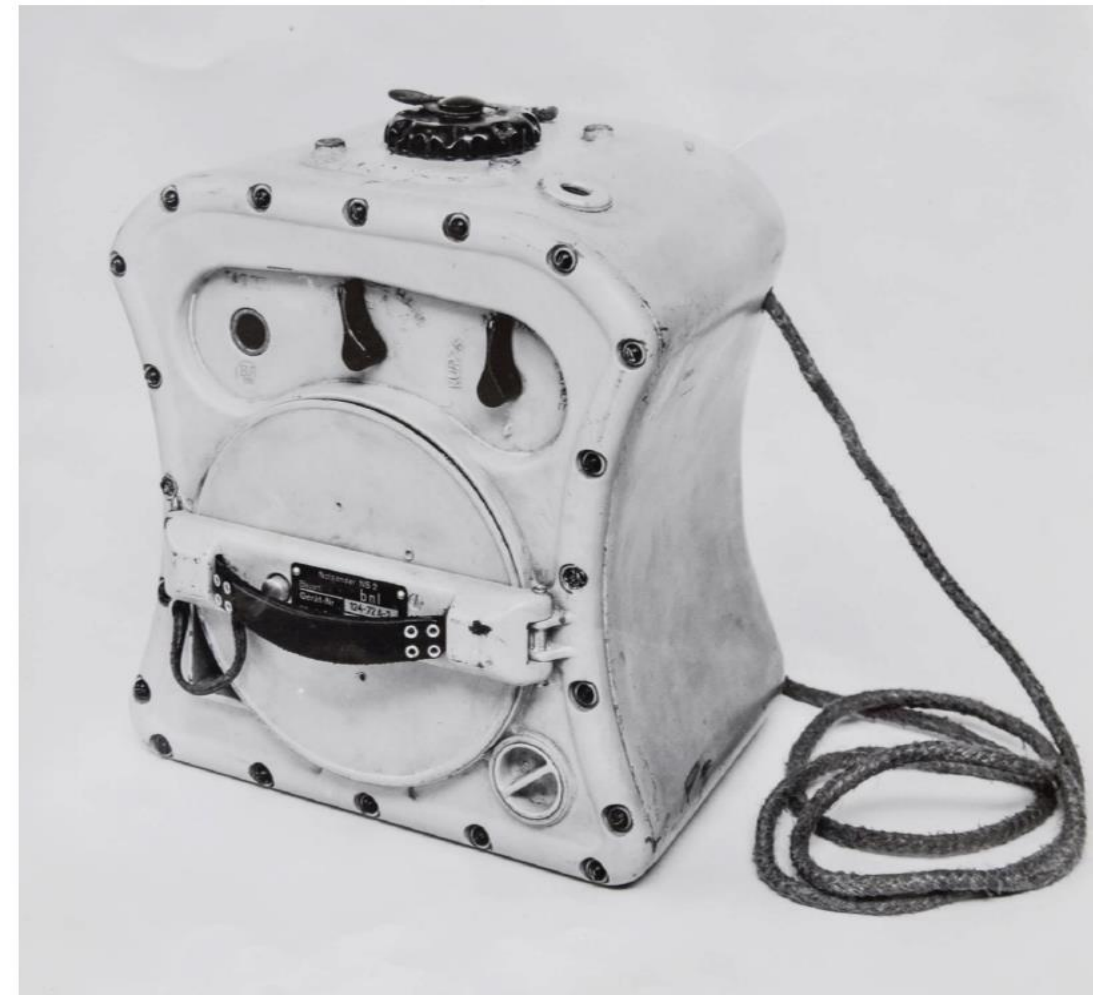
Fig. 26 Source: The National

Internal View of NS 2

Max range over land giving good Direction Finding bearings: 120 miles but signals audible at 160 miles

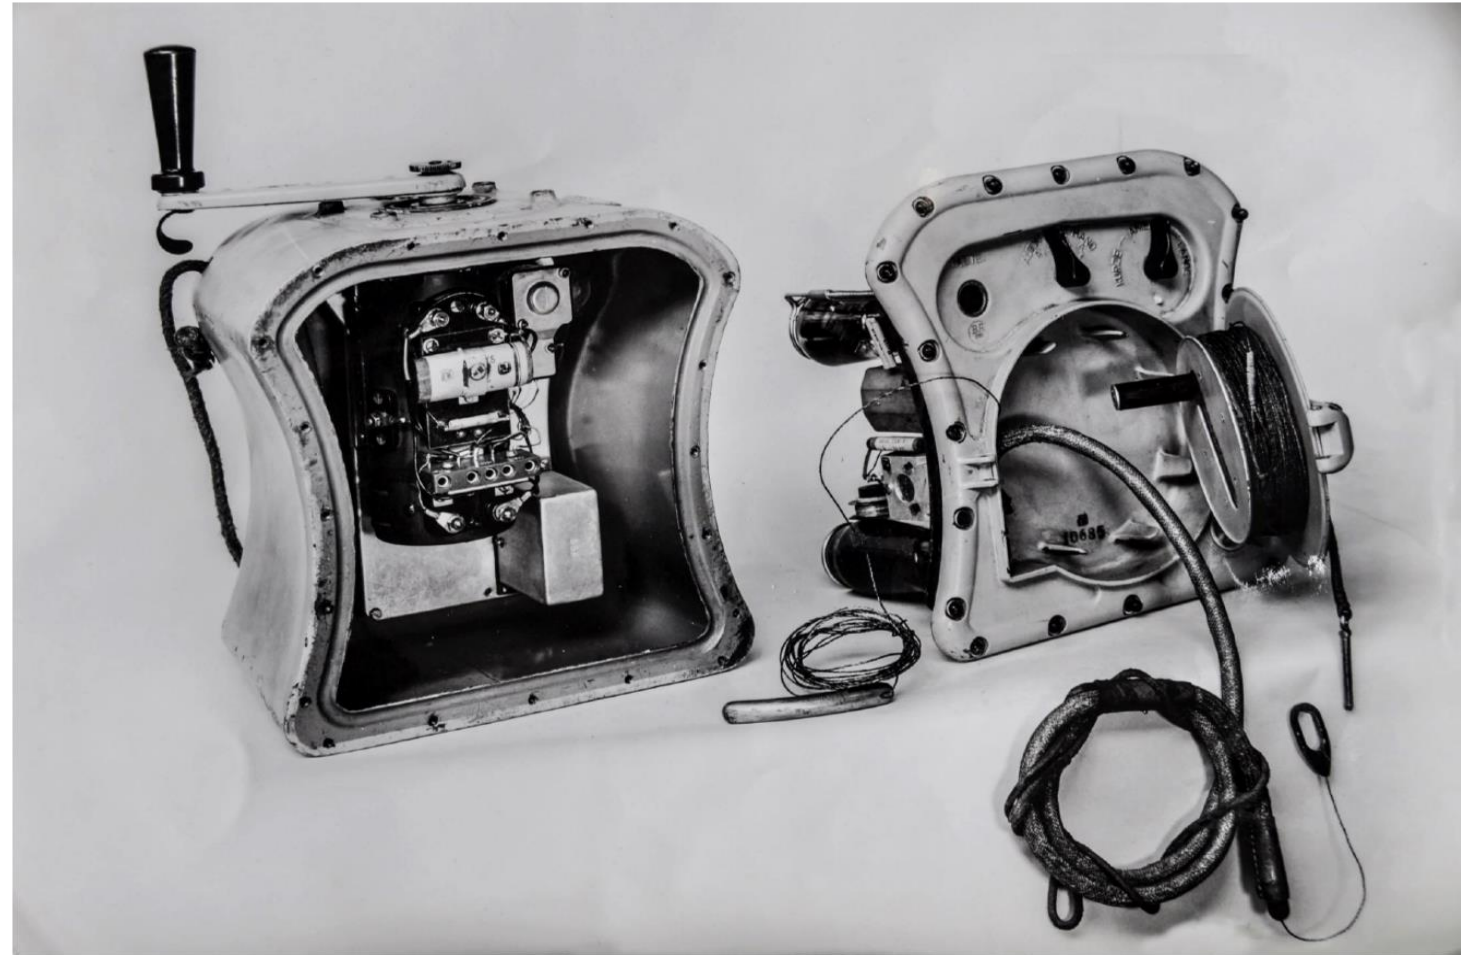
Fig. 27 Source: The National Archives

The cover is removed showing the internal arrangements and the integral aerial. The crank handle is on the top.

Note: Cranking the mechanism by turning a handle generated the power to send a homing signal, or the power to the transmitter/receiver for two-way communication in Morse Code. Cranking the handle was well within the capability of a cold, wet and thoroughly depressed survivor.

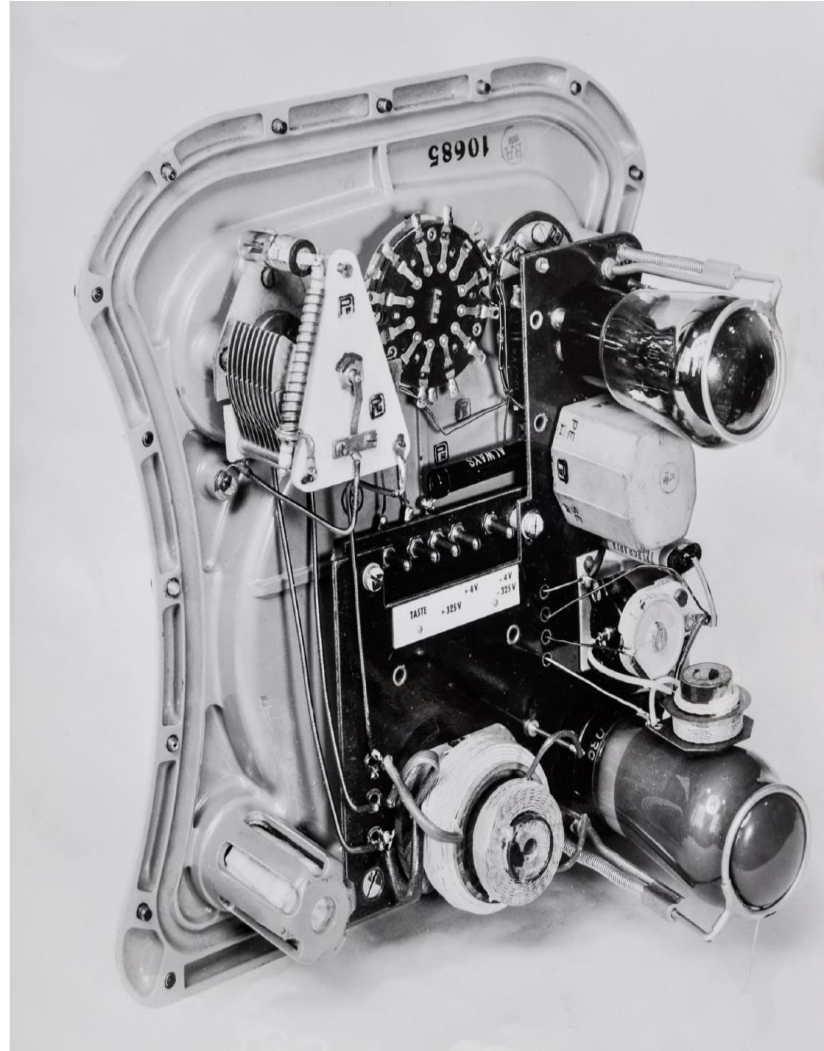
Fig. 28 Source: The National Archives

View of reverse of cover

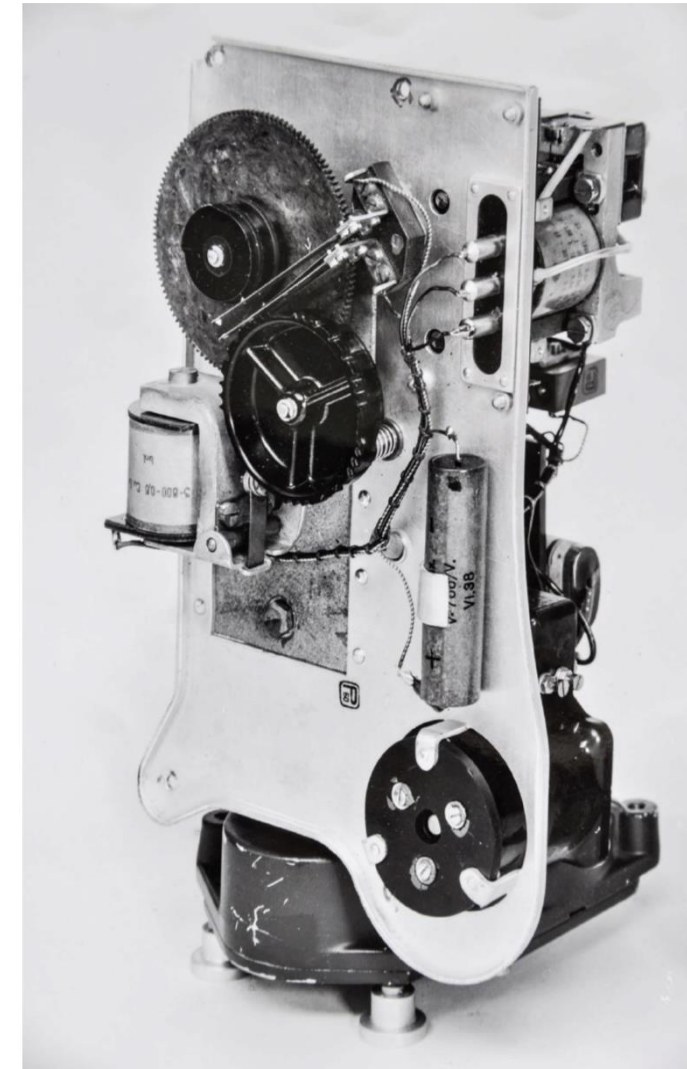
Fig. 29 Source: The National Archives

View of crank mechanism
